**Flood Control Project Maintenance  
Levee Inspections**

**Fall 2012 Levee Maintenance Deficiency Summary Report**

**Reclamation District No. 2063 Crows Landing**

**Levee Inspection Report By Mile - Fall 2012**

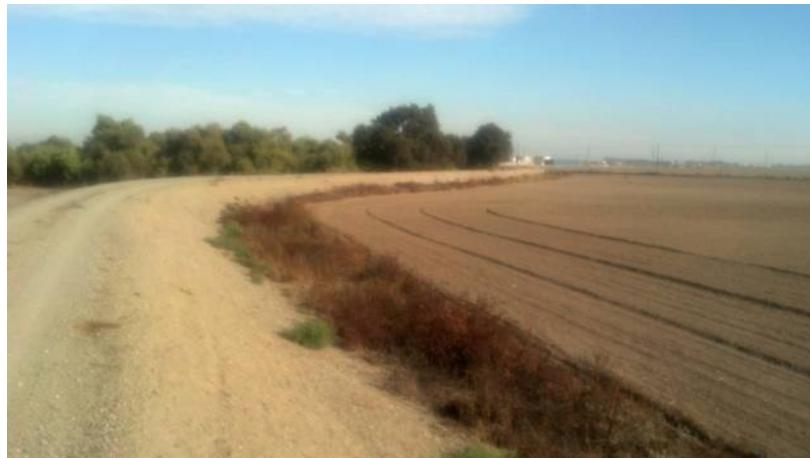
Levee Mile Report Line	5
Start Levee Mile	0.02
End Levee Mile	0.51
Location	Water Side
Category	Earthen Levee
Item	Vegetation

Looking south at typical view of levee slope.

DWR ID: DWR_RD2063_01_s_2012_3	
6	0.02 0.51	Earthen Levee	Vegetation	LS A/W Ma	V2 : Remove the wild growth other than native grasses from the levee slopes.		37.478548 ° -121.044605 °	37.471545 ° -121.044553 °	2	
									DWR ID: DWR_RD2063_01_s_2012_2	
7	0.03 0.49	Earthen Levee	Encroachments	LS U En	DT : Ditch Inspector Comments: Ditch on landside has encroached into the berm and toe of the levee.		37.478470 ° -121.044598 °	37.471848 ° -121.044635 °	18	
									DWR ID: DWR_RD2063_01_s_2012_18	
8	0.14 0.22	Earthen Levee	Encroachments	LS A/W En	PR : Prunings		37.476855 ° -121.044622 °	37.475658 ° -121.044603 °	16	
									DWR ID: DWR_RD2063_01_s_2012_16	
9	1.35 1.35	Earthen Levee	Encroachments	LS M En	RA : Ramp Inspector Comments: Ramp does not meet CVFPB standards. Ramp has 18-20" vertical cut at landside shoulder.		37.464308 ° -121.032603 °	37.464308 ° -121.032603 °	6	
									DWR ID: DWR_RD2063_01_s_2012_6

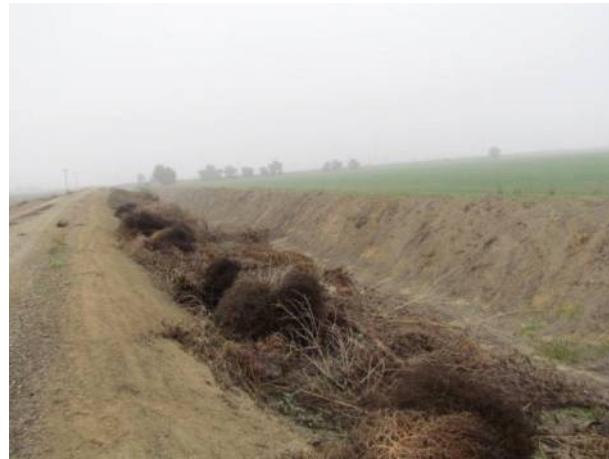
Levee Mile Report Line	7
Start Levee Mile	0.03
End Levee Mile	0.49
Location	Land Side
Category	Earthen Levee
Item	Encroachments

Looking north at ditch on landside berm and toe.

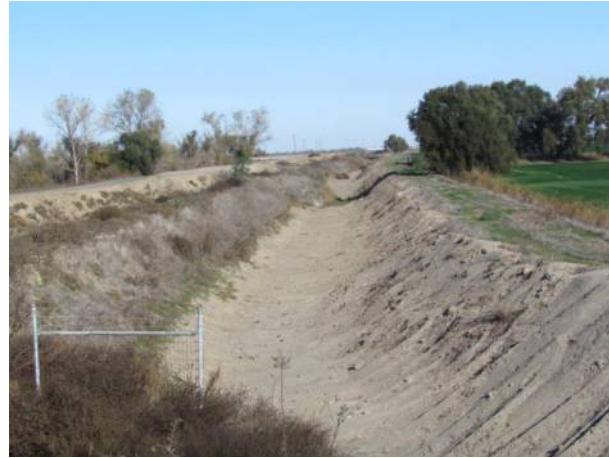
Levee Mile Report Line	7
Start Levee Mile	0.03
End Levee Mile	0.49
Location	Land Side
Category	Earthen Levee
Item	Encroachments

Looking south at canal-ditch at landside berm and toe.

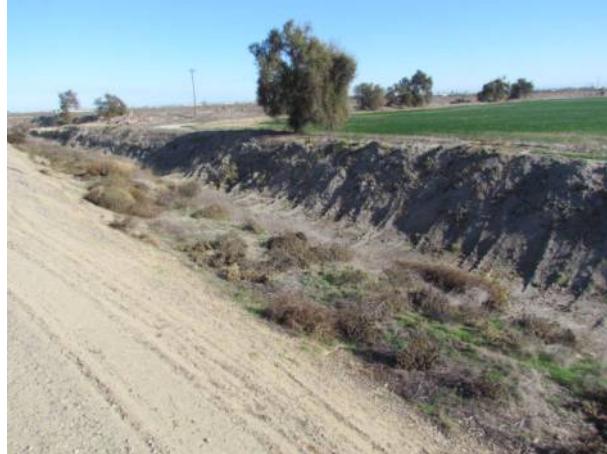
Levee Mile Report Line	7
Start Levee Mile	0.03
End Levee Mile	0.49
Location	Land Side
Category	Earthen Levee
Item	Encroachments
Looking northeast at canal-ditch on landside berm.	
<i>richard_f_20121101_834.jpg</i>

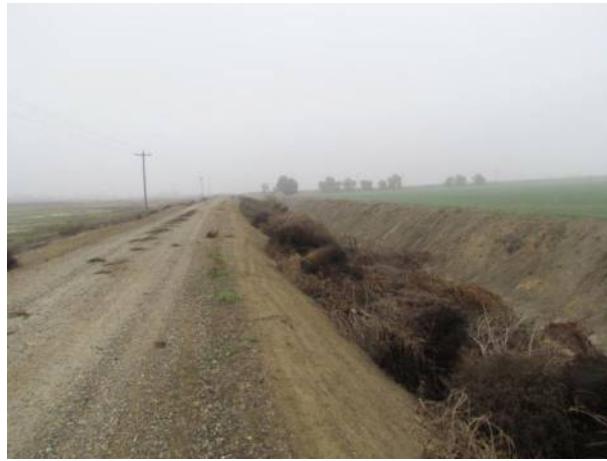
Levee Mile Report Line	8
Start Levee Mile	0.14
End Levee Mile	0.22
Location	Land Side
Category	Earthen Levee
Item	Encroachments
Looking north at prunings stacked on landside toe and berm.	
<i>richard_f_20121101_831.jpg</i>

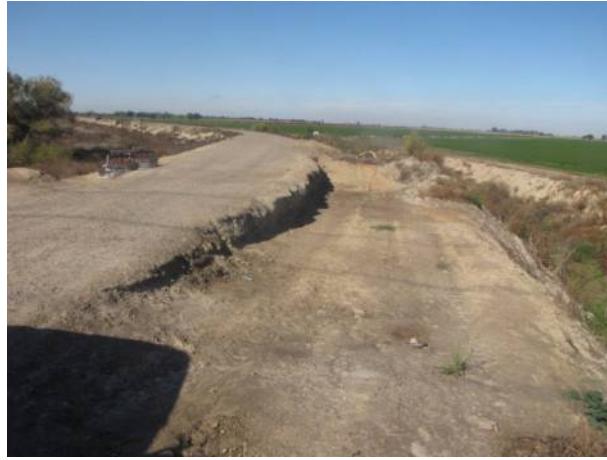
Levee Mile Report Line	9
Start Levee Mile	1.35
End Levee Mile	1.35
Location	Land Side
Category	Earthen Levee
Item	Encroachments
Looking north at ramp and equipment working pad on landside slope with a 18-20" vertical cut at shoulder.	
<i>richard_f_20121101_817.jpg</i>

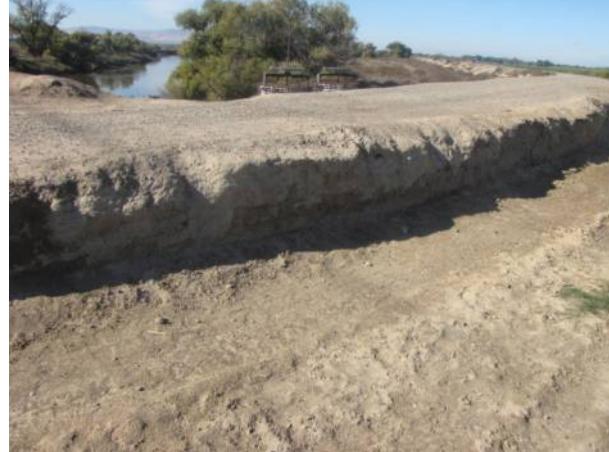
Levee Mile Report Line	9
Start Levee Mile	1.35
End Levee Mile	1.35
Location	Land Side
Category	Earthen Levee
Item	Encroachments
Looking west at 18-20" vertical cut for ramp on landside shoulder and slope	
richard_f_20121101_818.jpg

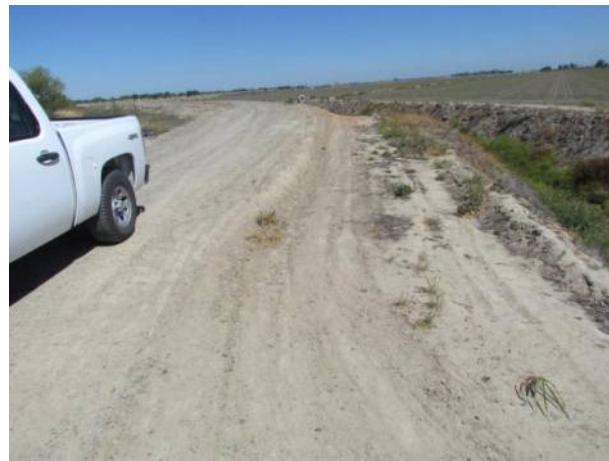
Levee Mile Report Line	9
Start Levee Mile	1.35
End Levee Mile	1.35
Location	Land Side
Category	Earthen Levee
Item	Encroachments
Looking north at vertical cut on landside shoulder and slope (Spring 2012)	
richard_f_20121101_819.jpg

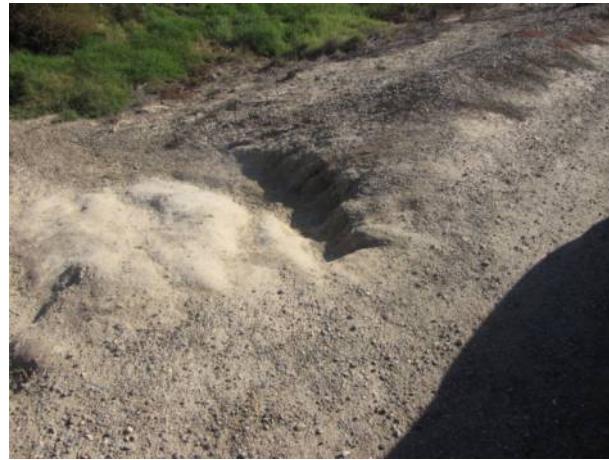
Levee Mile Report Line	11
Start Levee Mile	1.54
End Levee Mile	1.54
Location	Land Side
Category	Earthen Levee
Item	Slope Stability
Looking east at landside slope damage (six to eight inch erosion) by vehicle	
richard_f_20121101_820.jpg

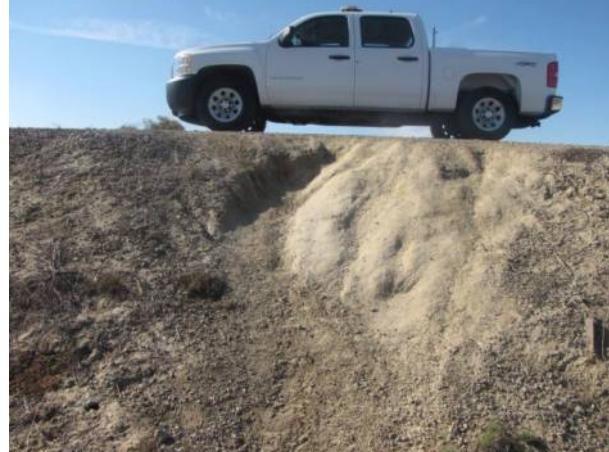
Levee Mile Report Line	11
Start Levee Mile	1.54
End Levee Mile	1.54
Location	Land Side
Category	Earthen Levee
Item	Slope Stability
Looking west at landside slope damage cause by vehicle traffic.	
richard_f_20121101_821.jpg

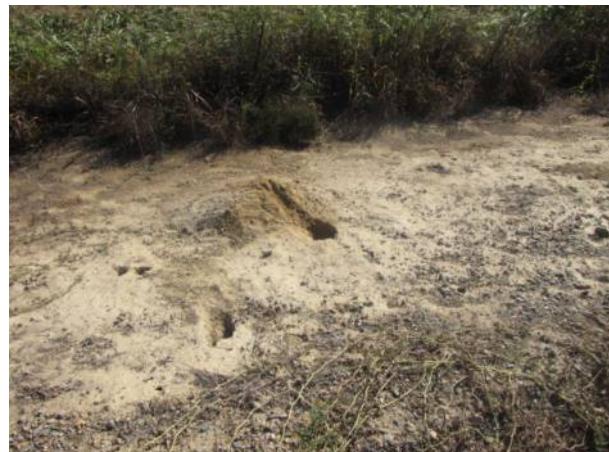
Levee Mile Report Line	13
Start Levee Mile	1.69
End Levee Mile	1.69
Location	Land Side
Category	Earthen Levee
Item	Animal Control
Looking east at squirrel holes on landside slope.	
richard_f_20121101_822.jpg

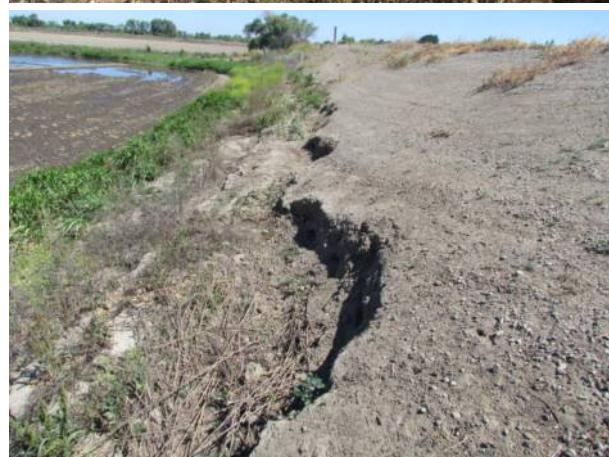
Levee Mile Report Line	15
Start Levee Mile	1.88
End Levee Mile	1.92
Location	Water Side
Category	Earthen Levee
Item	Erosion / Bank Caving
Looking north at erosion along waterward slope.	
richard_f_20121101_843.jpg

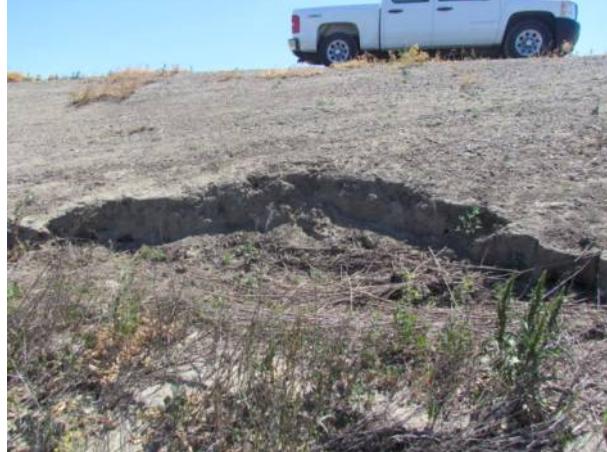
Levee Mile Report Line	15
Start Levee Mile	1.88
End Levee Mile	1.92
Location	Water Side
Category	Earthen Levee
Item	Erosion / Bank Caving
Looking east at erosion along waterward slope.	
<i>richard_f_20121101_844.jpg</i>

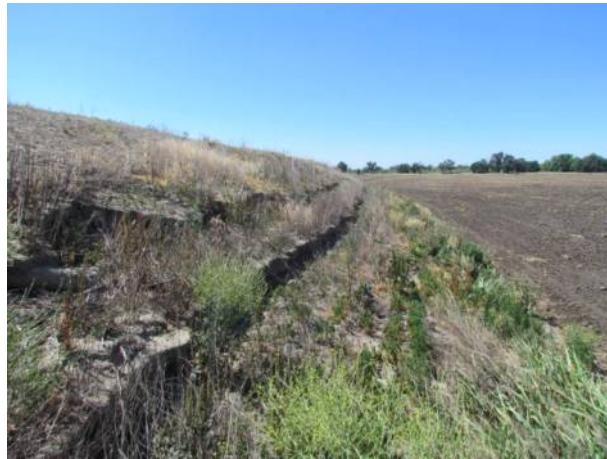
Levee Mile Report Line	15
Start Levee Mile	1.88
End Levee Mile	1.92
Location	Water Side
Category	Earthen Levee
Item	Erosion / Bank Caving
Looking south at erosion along waterward slope.	
<i>richard_f_20121101_845.jpg</i>

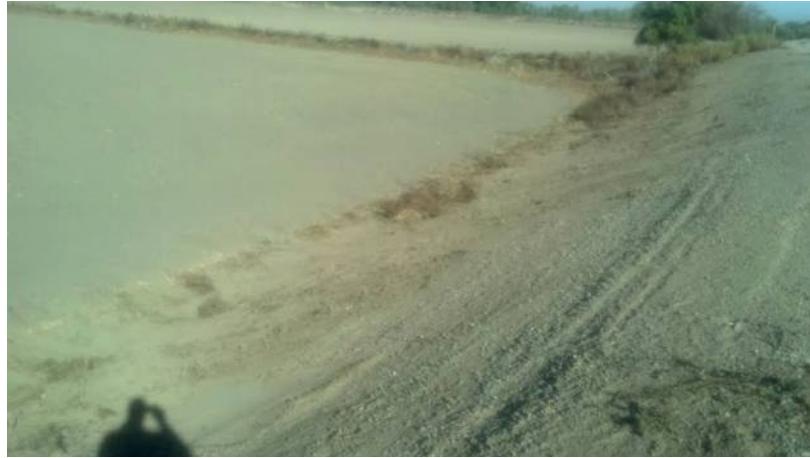
Levee Mile Report Line	15
Start Levee Mile	1.88
End Levee Mile	1.92
Location	Water Side
Category	Earthen Levee
Item	Erosion / Bank Caving
Looking north at repaired erosion along waterside slope and toe. (Fall 2012)	
<i>richard_f_20121115_916.jpg</i>

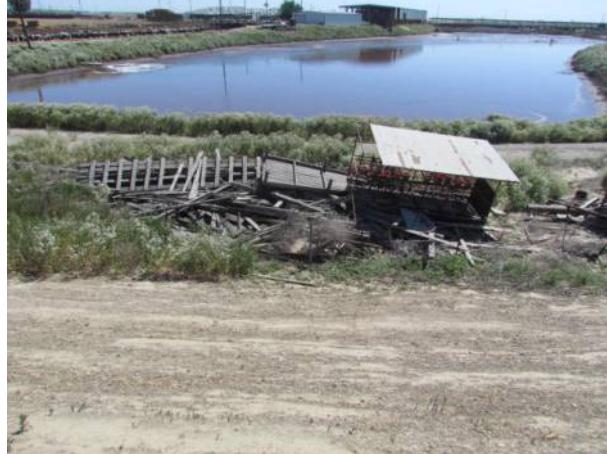
Levee Mile Report Line	16
Start Levee Mile	1.95
End Levee Mile	1.95
Location	Land Side
Category	Earthen Levee
Item	Encroachments
Looking east at garbage at landside toe.	
richard_f_20121101_846.jpg

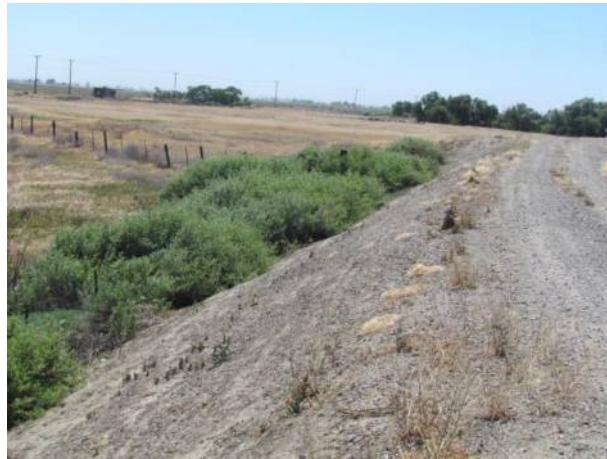
Levee Mile Report Line	19
Start Levee Mile	2.53
End Levee Mile	2.56
Location	Land Side
Category	Earthen Levee
Item	Vegetation
Looking south at dense vegetation on landside toe.	
richard_f_20121101_829.jpg

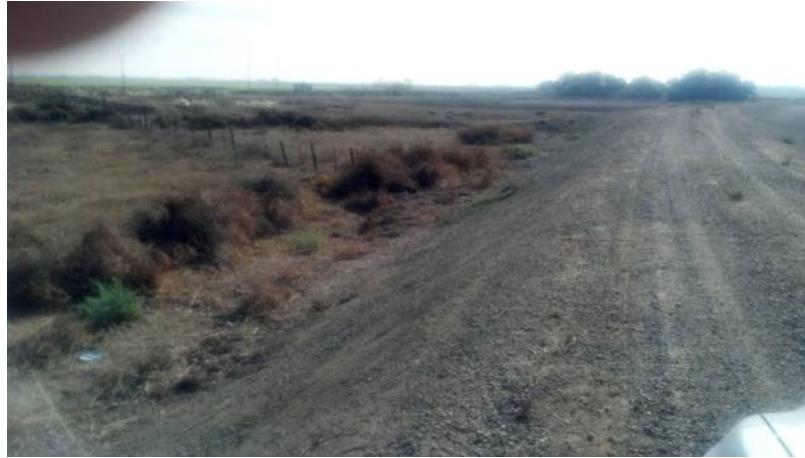
Levee Mile Report Line	19
Start Levee Mile	2.53
End Levee Mile	2.56
Location	Land Side
Category	Earthen Levee
Item	Vegetation
Looking south at cleared vegetation site on landside toe. (Fall 2012)	
richard_f_20121115_918.jpg

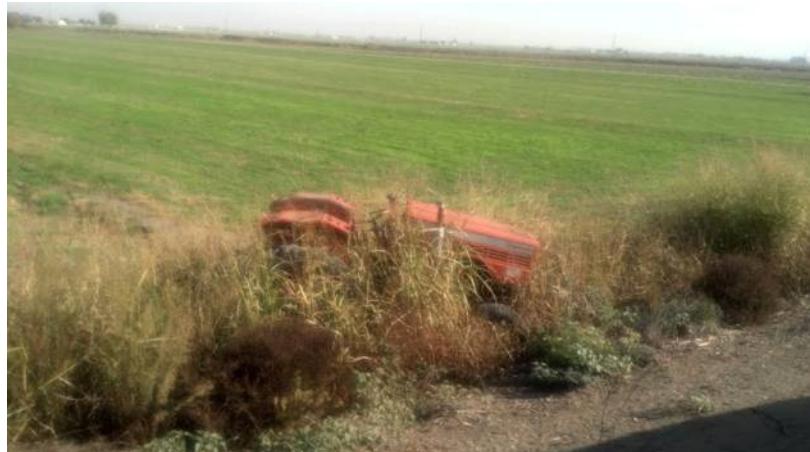
Levee Mile Report Line	22
Start Levee Mile	3.06
End Levee Mile	3.06
Location	Land Side
Category	Earthen Levee
Item	Encroachments

-121.025640 °	-121.025528 °		
								DWR ID: DWR_RD2063_01_s_2012_14			
22	3.06	3.06	Earthen Levee	Encroachments	LS En	M	EQ : Equipment Inspector Comments: Farm tractor stored at landside toe should be removed.	37.442822 °	37.442822 °	28	
								-121.025417 °	-121.025417 °	Y	
								DWR ID: DWR_RD2063_01_f_2012_28			
23	3.06	3.06	Earthen Levee	Erosion / Bank Caving	WS Ma	M	E2 : Schedule repair of erosion site prior to the next inspection. Inspector Comments: Several erosion sites located along waterside slope and toe approx. 100' plus feet long, 18-24 inches vertical cuts.	37.442816 °	37.442816 °	30	
								-121.025421 °	-121.025421 °	Y	
								DWR ID: DWR_RD2063_01_f_2012_30

Looking east at tractor at landside toe.

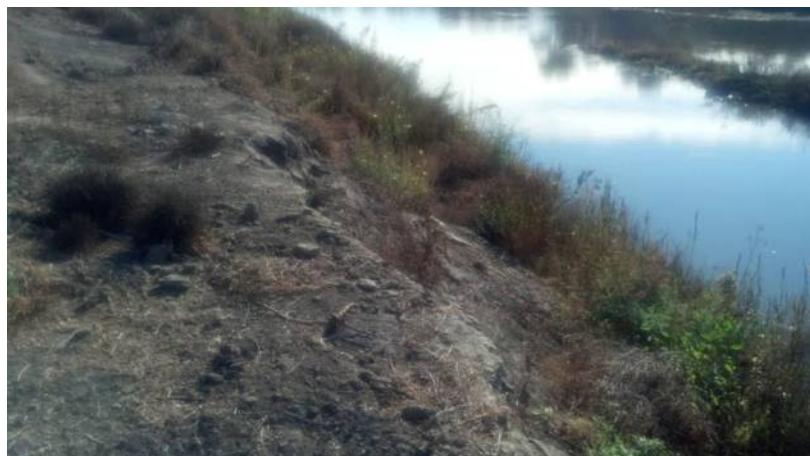
Levee Mile Report Line	23
Start Levee Mile	3.06
End Levee Mile	3.06
Location	Water Side
Category	Earthen Levee
Item	Erosion / Bank Caving

Looking southwest at river erosion at waterside slope and toe.

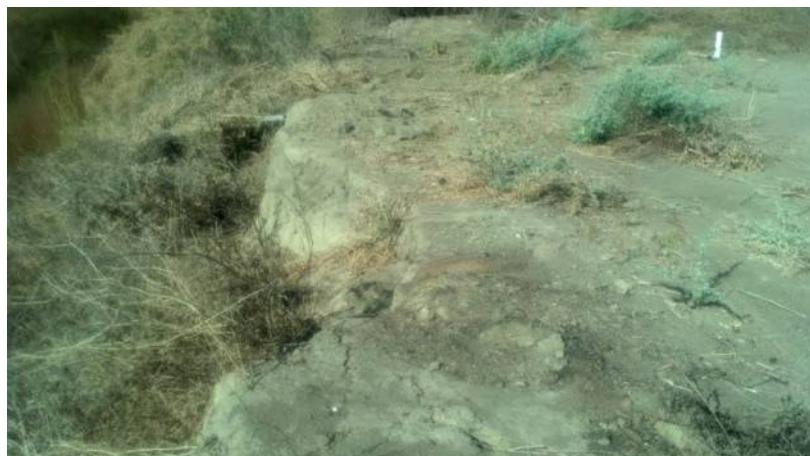
Levee Mile Report Line	23
Start Levee Mile	3.06
End Levee Mile	3.06
Location	Water Side
Category	Earthen Levee
Item	Erosion / Bank Caving

Looking northwest at river erosion at waterside slope and toe.

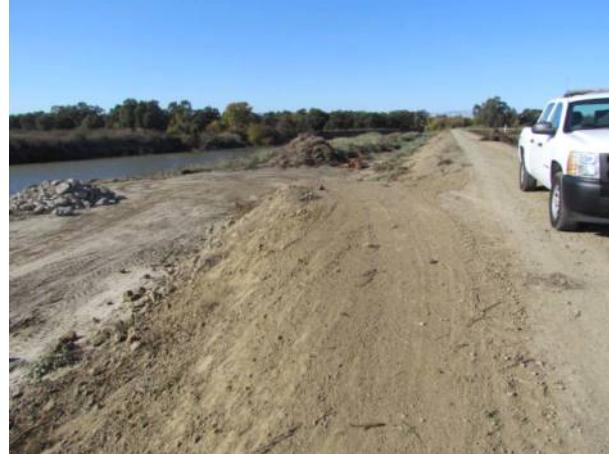
25	3.16	3.16	Earthen Levee	Encroachments WS M En	RA : Ramp		Inspector Comments: Unauthorized ramp installed to access erosion site. Ramp should be removed or the district should apply for a permit to maintain ramp.	37.442510 ° -121.023772 °	37.442510 ° -121.023772 °	26 Y	
26	3.41	3.70	Earthen Levee	Vegetation LS M Ma	V2 : Remove the wild growth other than native grasses from the levee slopes.		Inspector Comments: landside toe	37.440438 ° -121.020487 °	37.436906 ° -121.017835 °	38	
27	3.82	3.82	Earthen Levee	Animal Control LS M Ma	A3 : No rodents visible, but rodent burrows visible; need to backfill and compact or grout burrows.			37.435732 ° -121.016090 °	37.435732 ° -121.016090 °	29 Y	
28	3.96	4.10	Earthen Levee	Vegetation LS M Ma	V2 : Remove the wild growth other than native grasses from the levee slopes.			37.434403 ° -121.014298 °	37.432653 ° -121.013327 °	17 Y	
29	4.04	4.04	Earthen Levee	Encroachments WS C En	PI : Pipe		Inspector Comments: Inch and a half electrical conduit 1 foot below levee crown and slope should be removed.	37.433255 ° -121.013560 °	37.433255 ° -121.013560 °	15

Levee Mile Report Line	25
Start Levee Mile	3.16
End Levee Mile	3.16
Location	Water Side
Category	Earthen Levee
Item	Encroachments
Looking south at unauthorized ramp on waterside slope.	
richard_f_20121101_836.jpg

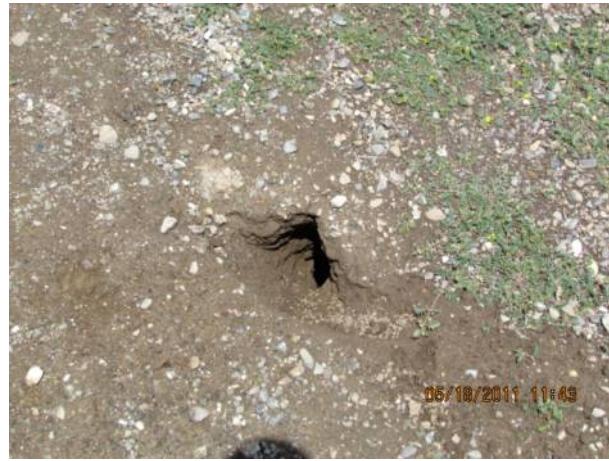
Levee Mile Report Line	27
Start Levee Mile	3.82
End Levee Mile	3.82
Location	Land Side
Category	Earthen Levee
Item	Animal Control
Looking at typical view of a squirrel hole on landside shoulder.	
richard_f_20121101_837.jpg

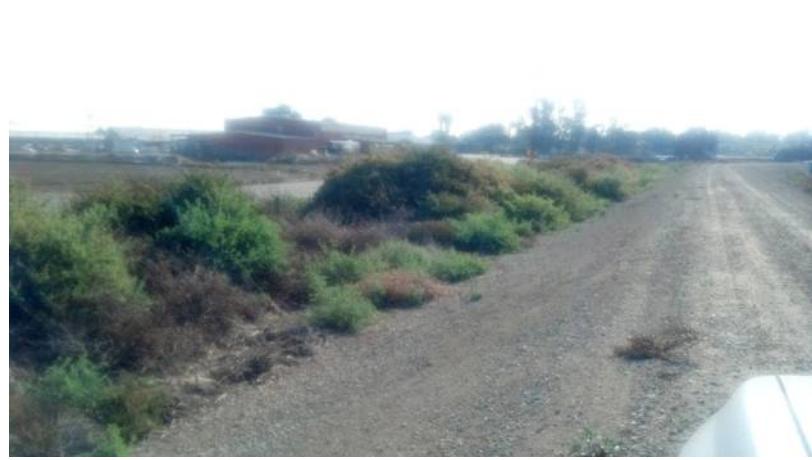
Levee Mile Report Line	28
Start Levee Mile	3.96
End Levee Mile	4.10
Location	Land Side
Category	Earthen Levee
Item	Vegetation
Looking southeast at dense vegetation along landside toe.	
richard_f_20121115_922.jpg

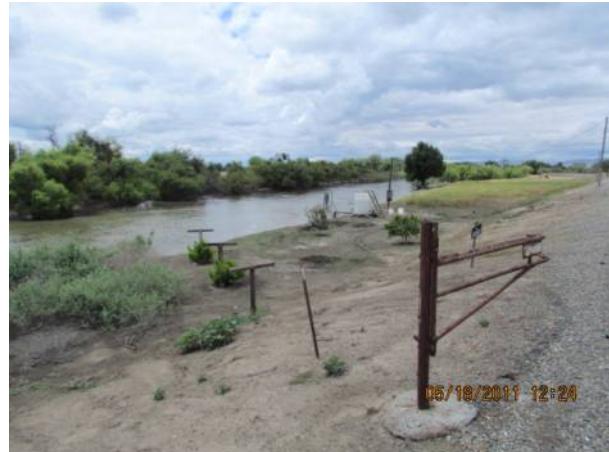
Levee Mile Report Line	31
Start Levee Mile	4.68
End Levee Mile	4.68
Location	Water Side
Category	Earthen Levee
Item	Encroachments
Looking south at grapevines and fruit trees on waterside berm.	
richard_f_20121101_838.jpg

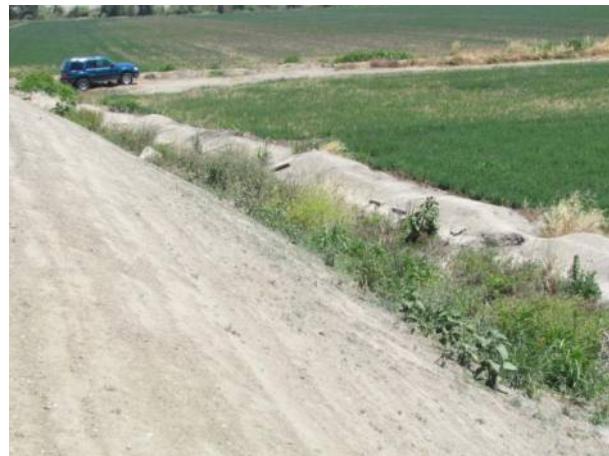
Levee Mile Report Line	33
Start Levee Mile	5.05
End Levee Mile	5.11
Location	Land Side
Category	Earthen Levee
Item	Encroachments
Looking northeast at irrigation ditch at landside toe.	
richard_f_20121101_848.jpg

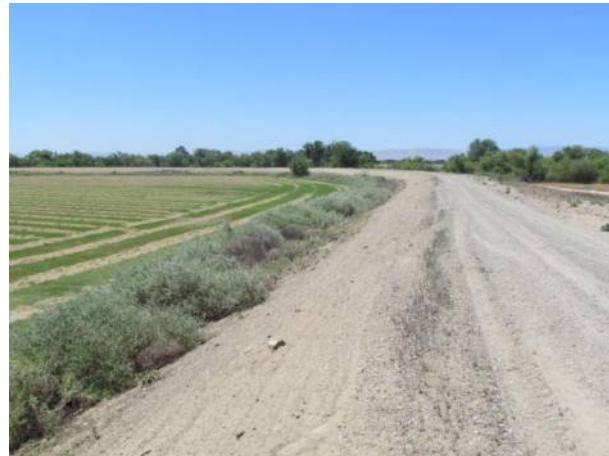
Levee Mile Report Line	38
Start Levee Mile	6.15
End Levee Mile	6.36
Location	Land Side
Category	Earthen Levee
Item	Vegetation
Looking south at dense vegetation on landside toe.	
richard_f_20121101_849.jpg

38	6.15	6.36	Earthen Levee	Vegetation	LS	A/W Ma	V2 : Remove the wild growth other than native grasses from the levee slopes.	37.415488 °	37.413473 °	120 -120.998988 ° -121.001680 ° Y DWR ID: DWR_RD2063_01_s_2012_120
39	6.89	6.89	Earthen Levee	Trim / Thin Trees	LS	A/W Ma	T1 : Trim trees to at least five feet above ground level.	37.411785 °	37.411785 °	39 -120.993548 ° -120.993548 ° DWR ID: DWR_RD2063_01_s_2012_39
40	7.69	7.69	Earthen Levee	Trim / Thin Trees	LS	A/W Ma	T1 : Trim trees to at least five feet above ground level.	37.403516 °	37.403516 °	7 -120.985718 ° -120.985718 ° DWR ID: DWR_RD2063_01_s_2012_7
41	7.81	7.90	Earthen Levee	Vegetation	LS	M Ma	V2 : Remove the wild growth other than native grasses from the levee slopes.	37.402400 °	37.401563 °	23 -120.984087 ° -120.982775 ° DWR ID: DWR_RD2063_01_s_2012_23
42	7.88	7.88	Earthen Levee	Trim / Thin Trees	LS	A/W Ma	T1 : Trim trees to at least five feet above ground level.	37.401774 °	37.401774 °	9 -120.983132 ° -120.983132 ° DWR ID: DWR_RD2063_01_s_2012_9

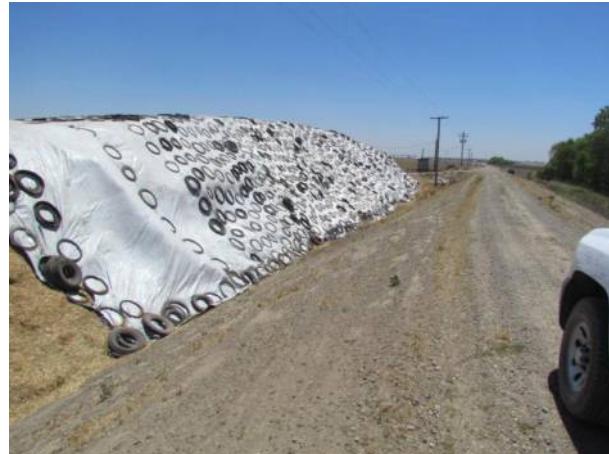
Levee Mile Report Line	45
Start Levee Mile	8.54
End Levee Mile	8.54
Location	Land Side
Category	Earthen Levee
Item	Encroachments
Looking south at hay stacked near landside toe.	
richard_f_20121101_850.jpg

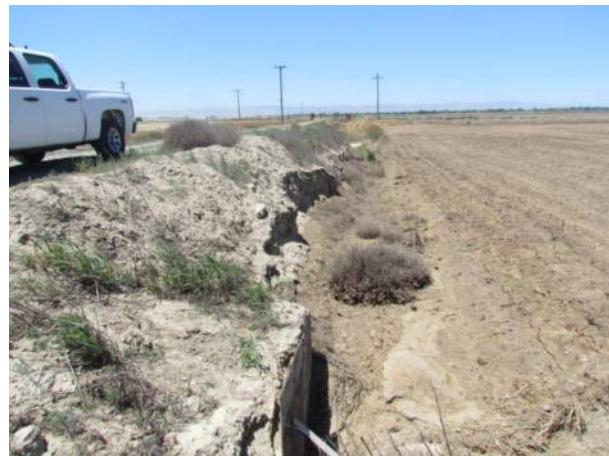
Levee Mile Report Line	47
Start Levee Mile	9.67
End Levee Mile	9.67
Location	Land Side
Category	Earthen Levee
Item	Erosion / Bank Caving
Looking northwest at landside erosion at levee toe.	
richard_f_20121101_851.jpg

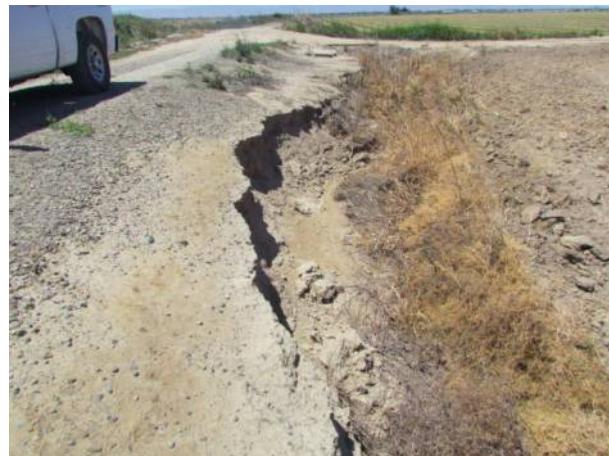
Levee Mile Report Line	48
Start Levee Mile	10.40
End Levee Mile	10.40
Location	Land Side
Category	Earthen Levee
Item	Erosion / Bank Caving
Looking northwest at landside erosion at levee toe.	
richard_f_20121101_852.jpg

LMR No.	Levee Mile		Category	Item	* Location	* Rating	Action/Comment	GPS Latitude/Longitude		Issue No.
	Start	End						Start	End	
48	10.40	10.40	Earthen Levee	Erosion / Bank Caving	LS U Ma	E2 : Schedule repair of erosion site prior to the next inspection. Inspector Comments: 36-48 inch vertical cut at landside toe.	37.390538 ° -120.945318 °	37.390538 ° -120.945318 °	123 Y
